# CONTROLLING POLLUTED STORMWATER RUNOFF FROM ROADS

*Beverley Wemple<sup>1</sup>*

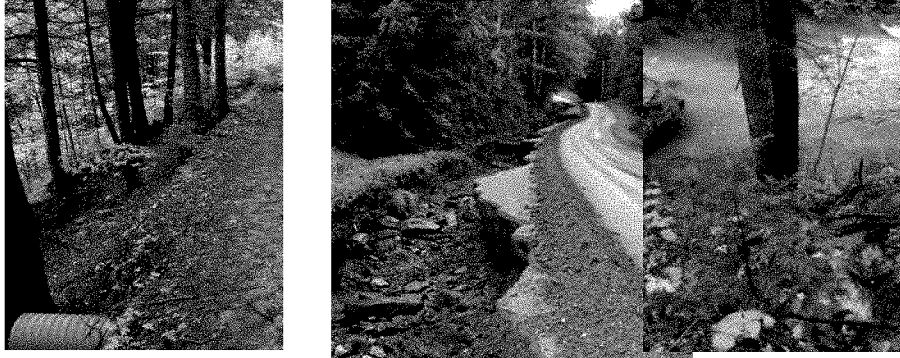
Figure 1: Evidence of water quality impacts associated with unpaved roads in Vermont's uplands: erosion of rills and gullies on impervious road surface (left panel), eroded roadside ditch resulting from channelized stormwater runoff (middle panel), direct discharge of road runoff to receiving stream from road culvert (right panel).

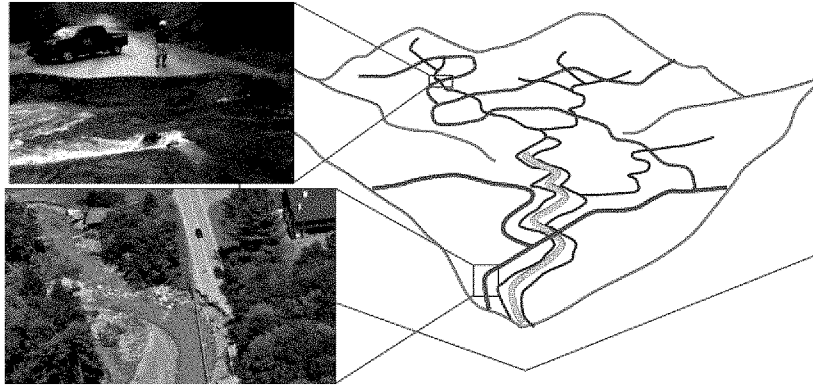
Figure 2: Right: block diagram illustrating characteristic location of roads in the northern New England and other mountain landscapes. In the lowlands, roads are preferentially situated in floodplains. In the uplands, roads traverse steep slopes and cross small-stream channels. Photos at the left show damage sustained on Vermont roads during Tropical Storm Irene in August of 2011 at a road-stream crossing in the uplands (top) and along a river corridor in the lowlands (bottom).

The mountainous terrain of the region and location of the transportation infrastructure gives rise to a set of interactions among rivers and roads that have implications both for infrastructure integrity and for water quality (Figure 2). Roads located in the lowlands, especially in the narrow valleys of the region, travel parallel to rivers, occupying floodplains once carved by rivers that moved laterally to accommodate floods but are now constrained by transportation infrastructure. During Tropical Storm Irene in August of 2011, these transportation corridors suffered tremendous damage as roads were undermined by rivers seeking to dissipate the energy of intense flood waters and the debris transported by them.<sup>26</sup> Over the long term, lateral constriction by transportation infrastructure limits the natural migration of rivers that provide important aquatic habitat and allow rivers to use their floodplains to dissipate energy and cleanse floodwaters of sediment and sediment-bound nutrients.<sup>27</sup> Roads located in the uplands traverse steep slopes with frequent crossings of small stream channels. In this upland setting, the mostly forested landscape is covered by soils with high infiltration rates, but steep topographic gradients give rise to higher precipitation rates in the uplands, thus, more water to accommodate. Water concentrated on impervious road surfaces and intercepted along road cuts is routed through a network of roadside ditches and typically discharged to receiving streams. This creates a chronic sourcing of stormwater and pollutants to these otherwise pristine streams but also an episodic risk to infrastructure during extreme storms, when the volume of runoff often exceeds the design capacity of ditches and culverts, leading to the types of infrastructure failure seen so commonly during Tropical Storm Irene and more recent floods in the region (Figure 2).

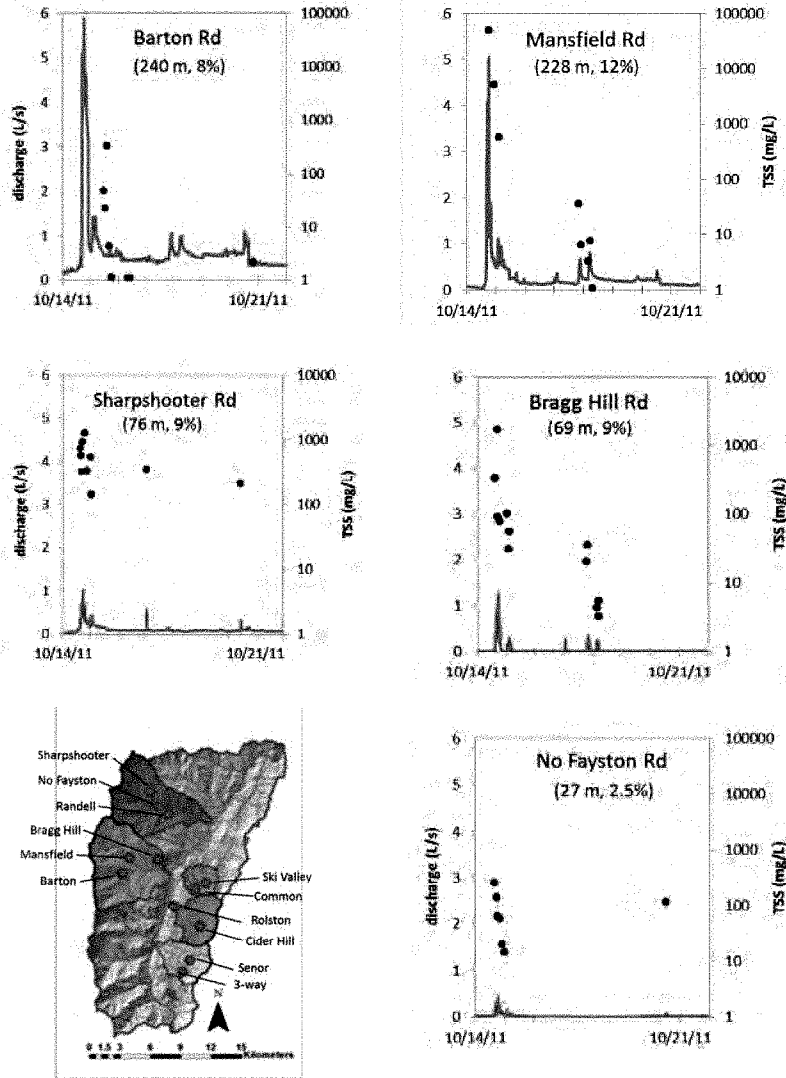
Figure 3: Measurements of stormwater production and suspended sediment concentrations in stormwater on five unpaved road segments in the Mad River Valley, monitored during an October 2011 storm event. Sites are displayed from upper left to lower right in order of decreasing road length (indicated in parentheses as meters of road draining to the measurement station). Road grade for each segment is also displayed in parentheses. Monitored site locations within the Mad River Valley for this and other storm events are shown in the inset map in the lower left panel within the small watersheds they are located. See Figure 5 for watershed names and loading estimates derived from these and other measurements.

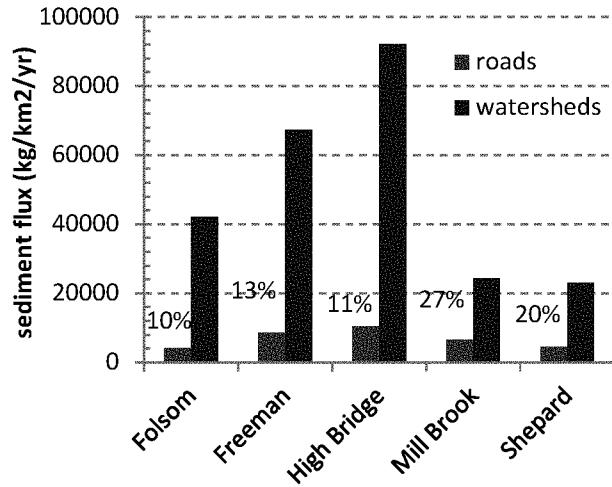
Figure 6: Comparison of estimated pollutant loads from unpaved roads (red bars) and small watersheds for suspended sediment (left panel) and total phosphorus (right panel). Percentage values above red bars are estimates of pollutant loads from roads as a fraction of estimates from watersheds.

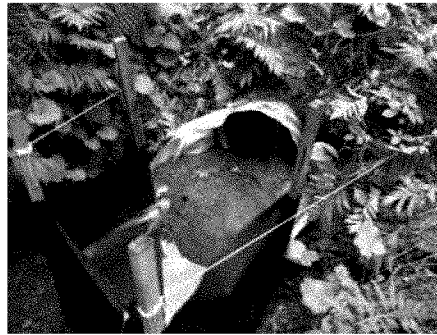
Figure 7: Silt fence constructed of plastic sheeting to retain sediment and filter fabric to pass stormwater, installed at culvert outlets to trap material eroded from roads and roadside ditches.

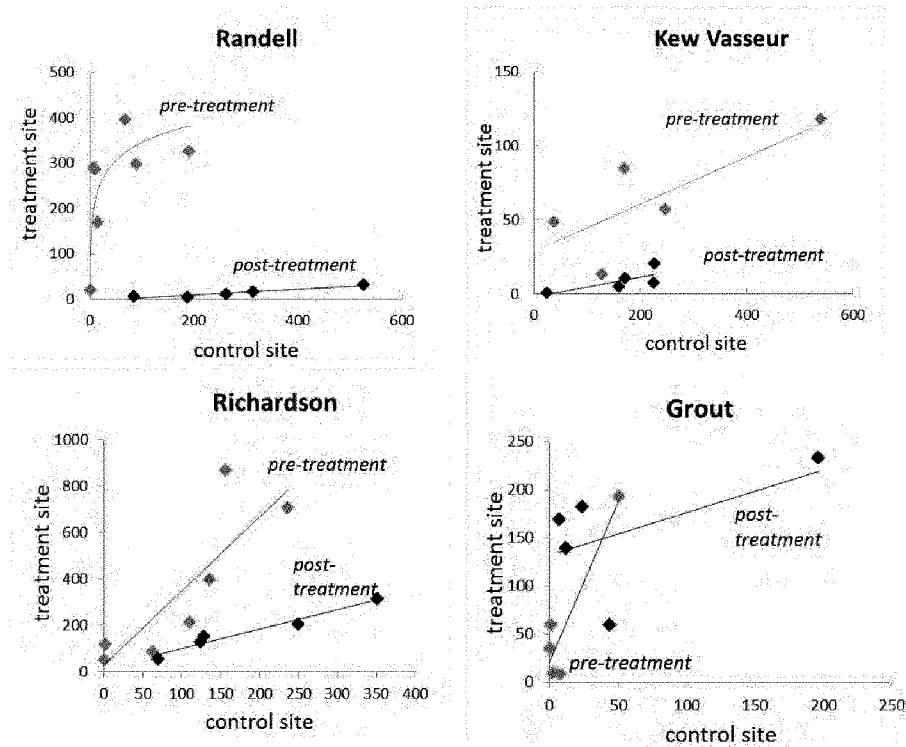
Figure 8: Examples of results from experimental installations of BMPs on select road segments in the Mad River watershed. Plots summarize mass (in kilograms) of dry sediment collected at silt fences (see Figure 7) at each site for individual storm events and compare a control site, plotted on the x-axis, to a treated site, plotted on the y-axis, for both the pre-treatment and post-treatment period. A downward shift in the relationship between treated and control site, as evidenced at the Randell, Kew Vasseur and Richardson Road sites, demonstrates success of the BMP following installation of the experimental "treatment."

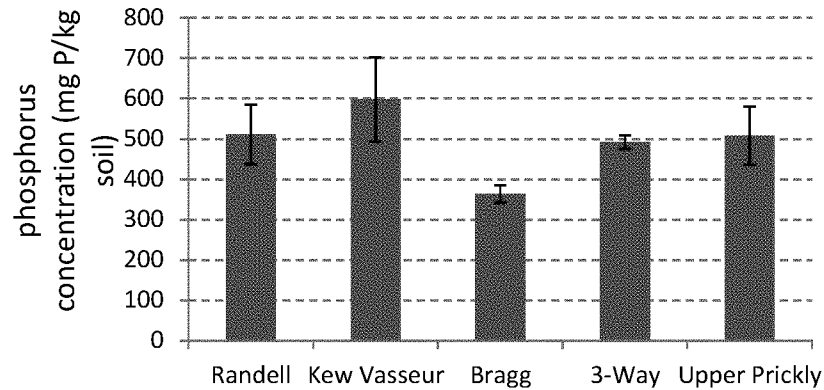
Figure 9: Total phosphorus concentration in bulk sediment samples collected in silt fences at five road sites in the Mad River Watershed. Bars are means of samples analyzed. Error bars are sample standard deviations.

Results from this work provide insights both into the magnitude of material eroded from unpaved roads we studied and the effectiveness of these recommended practices. Depending upon conditions of the site, roads selected by town officials for drainage improvements commonly eroded between 100 – 300 kilograms of dry soil during storm events, with some sites yielding even greater amounts.<sup>46</sup> As expected, sites selected as controls generally had lower erosion rates when compared to the treatment sites in the pre-treatment period.<sup>47</sup> Following installation of BMPs, erosion at the treated sites was substantially reduced in most cases, resulting in sediment runoff that more closely matched the lower rates measured at control sites.<sup>48</sup> In some cases, installation of BMPs proved ineffective.<sup>49</sup> For example, the Grout Road site in Duxbury experienced considerable erosion (up to and in excess of 150 kilograms of material per monitored storm) in the post-treatment period and the check dams and turnouts installed there were insufficient to control erosion of this magnitude (Figure 8). Phosphorus concentrations in eroded soil captured at the silt fences averaged 500 milligram of phosphorous per kilogram of dry soil (Figure 9). A reduction

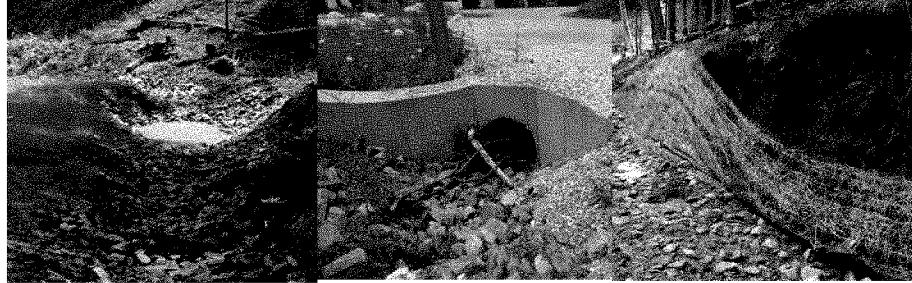
*Figure 10: Examples of assessed BMPs—left: intact stone lined ditch; middle: culvert compromised by debris partly plugging inlet; right: failed BMP installation showing evidence that stone and stabilization fabric have been undermined.*

To complement this experimental work, we also assessed 100 BMP installations at 43 sites funded by the Vermont Better Backroads Program over the past 8 years (the period for which records of project design and installation have been retained). The assessed sites were located in rural towns of northwestern and north-central Vermont, allowing us a broader geographical view across the state of practices employed and their efficacy. Our assessments involved review of the project design notes and a site visit to inspect conditions. For each BMP installation documented in the project notes and located in the field, we made a qualitative evaluation of condition, rating each as “intact” if the BMP appeared to be functioning to improve drainage and reduce on-site erosion, “compromised” if there was some evidence of reduced performance to drain water and prevent erosion and “failed” if the BMP as recorded on the project file had been undermined or destroyed (Figure 10).

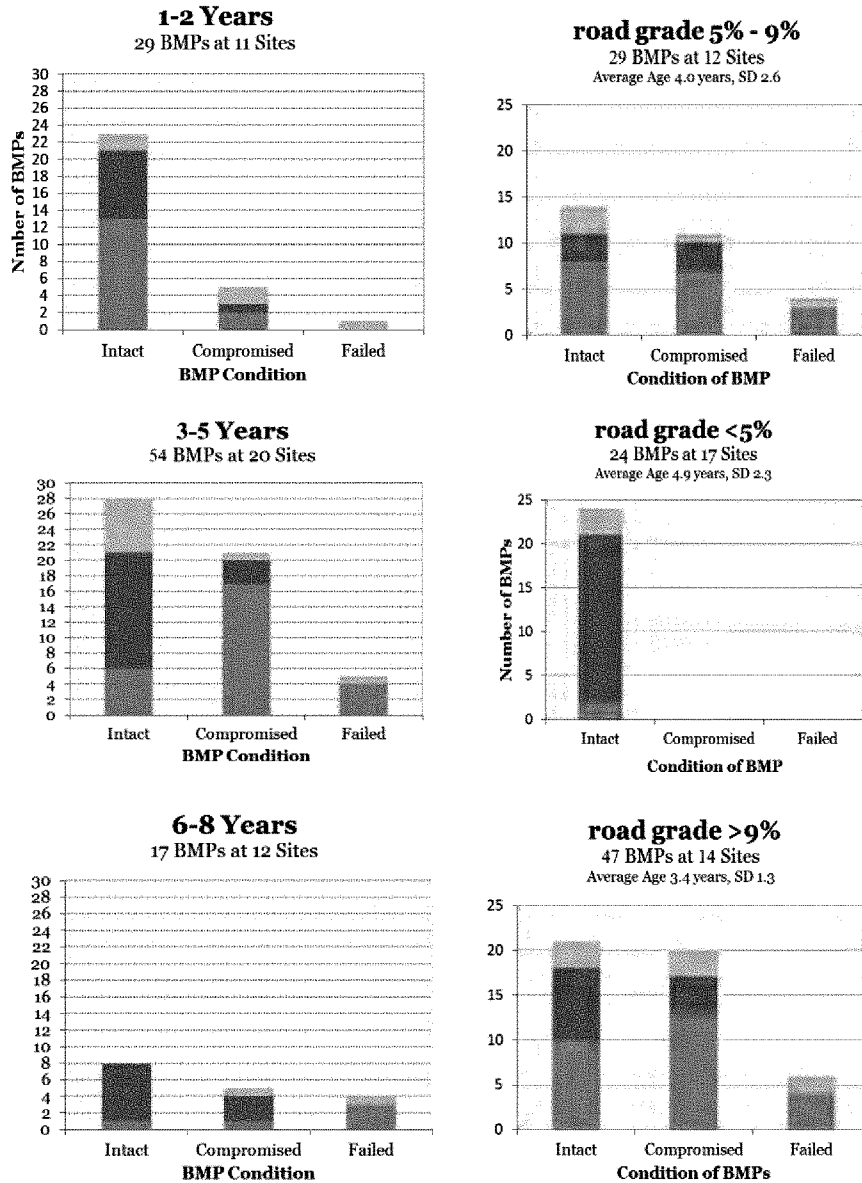
Figure 11: Condition of BMPs assessed grouped by age of project (left panel) and road grade (right panel). Bar colors = pink = stonework, blue = culverts, dark green = revetments, and light green = vegetative controls.

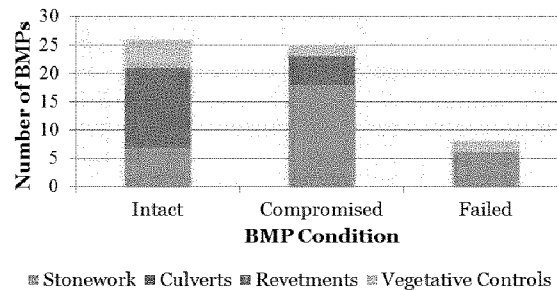
Figure 12: Condition of assessed BMPs exposed to flood events, as documented in the database of Castle et al, *supra* note 53.

Our retrospective assessment also showed that BMPs funded through the Vermont Better Backroads Program weathered extreme storms with considerable success (Figure 12).<sup>52</sup> We coded sites according to whether they had been exposed to an extreme flood since BMP installation by using the database of

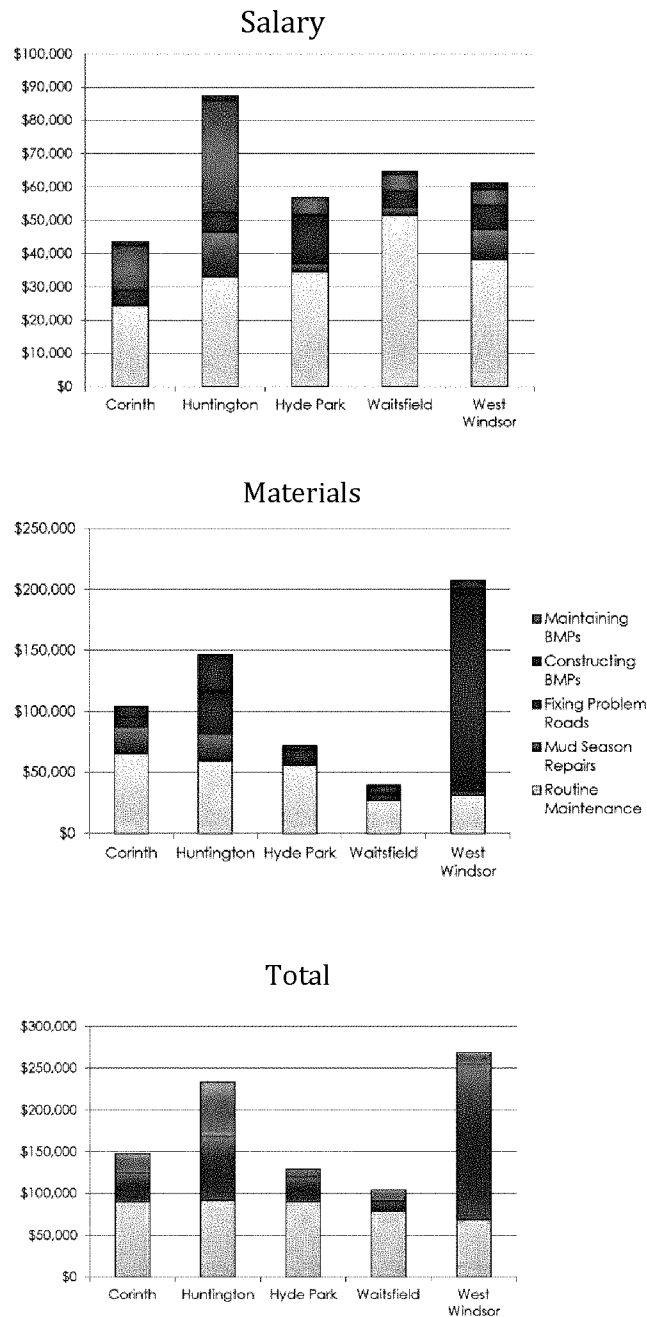
Figure 13: Graphs of estimated salary expenditures on staff salary (upper panel) and materials (middle panel) for non-winter work on gravel roads based on interview responses for five towns interviewed for this study. Lower panel is total of salary and materials with five expenditure categories summarized into routine maintenance (tan), repairs (red), and BMPs (green).

Interviews indicated that routine maintenance comprised the largest share of both salary and material expenditures for each of the towns studied (Figure 13). Four of the five towns studied had invested a smaller share of resources in the previous year on repair efforts following the snow-melt period (“mud season”) and storm events. One of the towns interviewed, West Windsor, had allocated more than three times the amount spent on routine maintenance to damage repairs in the previous year, an outcome of extensive storm damage that the town had experienced. West Windsor’s experience has likely been shared by other Vermont mountain towns impacted by severe storms in recent years based on statewide news reports of storm damage to road infrastructure.<sup>61</sup> Interviews also showed that each of the towns was allocating resources to BMP construction and maintenance, though this represented the smallest share of resource allocation (Figure 13). Huntington reported that they were investing more funds than in the past on BMP implementation in response to drainage improvements and reduced storm damage they had experienced following installation of Better-Backroads funded projects in recent years.<sup>62</sup> In total, the towns interviewed had spent in the budget year analyzed an average of \$70,000 on routine maintenance, less than \$15,000 to nearly \$200,000 on repairs, and between \$10,000 and \$60,000 on BMP construction and maintenance.<sup>63</sup>
